The DMAD Dam Spillway Failure-The Engineering Issues

Roger W. Walker
Sevier River Commissioner
Delta, Utah

Wynn R. Walker
Professor
Utah State University

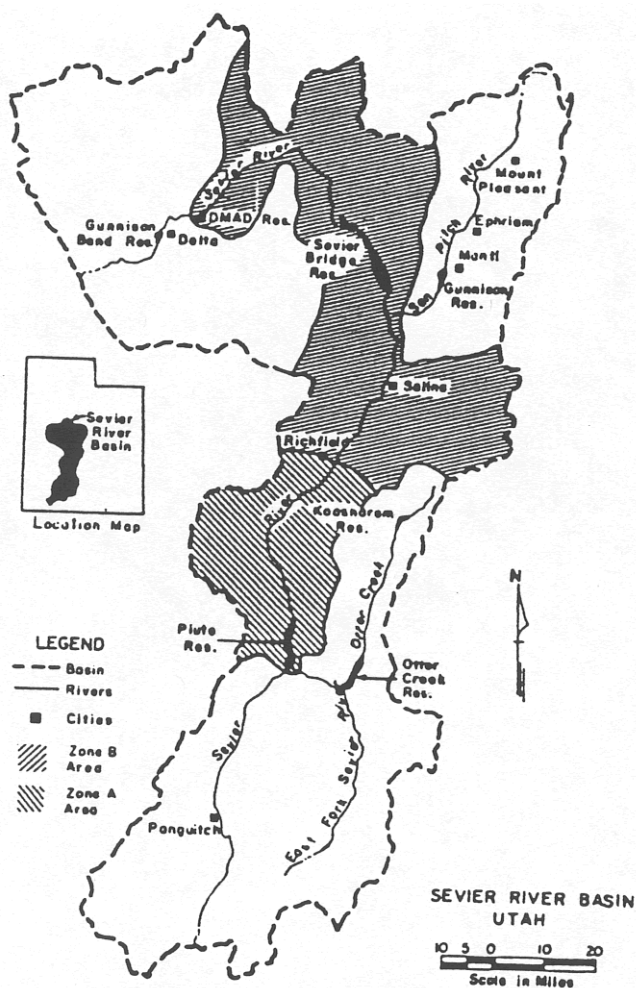
Figure 1. The location and setting of the DMAD Dam in the Sevier River Basin.

The DMAD Reservoir is a small storage and regulating facility in the lower Sevier River Basin (Figure 1). If the physical and operational aspects of the system had been major considerations in the DMAD design, it is unlikely that a failure of this magnitude would have resulted. The flooding conditions in 1983 exceeded the 10,000 year flood event and were dealt with by improvisation and innovation.

The second effect of the 1890's drought was the establishment of the various water rights. In the 1901 to 1906 period, the water resources were divided among the various claimants, but in two different regions of the basin shown in Figure 1. Thus, a single, interdependent hydrologic system was legally divided into two independently managed systems. In 1936, the system was placed under common decree to resolve conflicts between the two sections, but in effect left the operation of the system in two separate components. There was no provision to operate the system elements conjunctively in the event of a major flood.

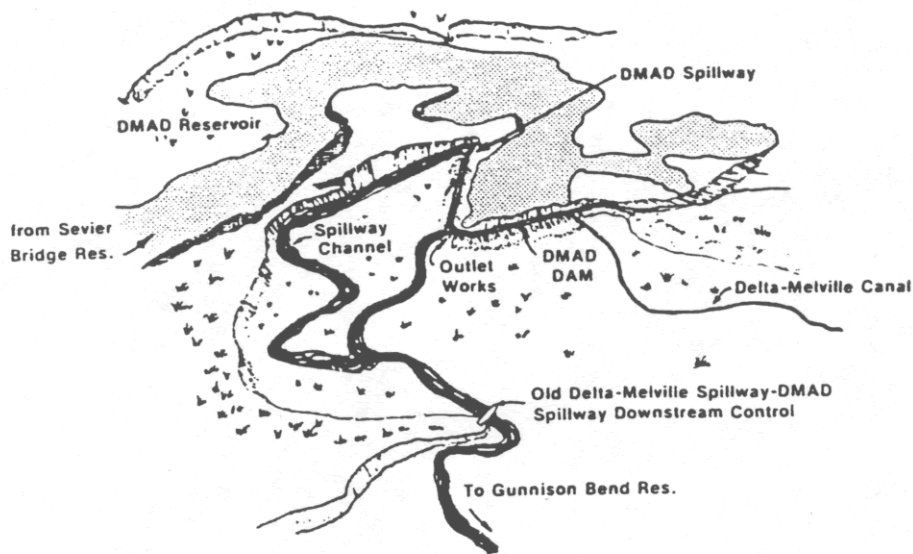
Figure 2. Site Layout of the DMAD Reservoir.

The DMAD Dam and Reservoir (Figure 2) was a cooperative project of the four local irrigation companies (Delta, Melville, Abraham, and Deseret Companies, and thus the name of DMAD). The Abraham and Deseret Companies own and operate the Gunnison Bend Reservoir downstream of DMAD (Figure 1) and have a first priority right to the first 9,300 acre-feet of winter flows below Sevier Bridge Reservoir. Prior to DMAD, the limited capacity of Gunnison Bend forced most of this winter flow to be used for irrigation in the off-season or lose the water to junior appropriators for storage in Fool Creek Reservoir. When the four companies joined and built DMAD, it afforded Abraham and Deseret better control of their water and it gave Delta and Melville substantially better regulation during the irrigation season. The Delta and Melville systems were originally supplied by a check-dam near the present dam site which was actually regulated at Sevier Bridge Reservoir about 3 days of river travel time upstream. It is important to note that the original Delta-Melville diversion was protected by a spillway which later became the downstream control on the DMAD spillway some 3/4 mile upstream.
