# Ancient Machu Picchu Drainage Engineering

**ABSTRACT:** The drainage infrastructure constructed by the Inca at ancient Machu Picchu represents a significant public works achievement. The difficult site constraints associated with the nearly 2,000 mm per year of rainfall, steep slopes, landslides, and inaccessibility posed drainage challenges that were met successfully by the Inca. The technical analysis of the Inca drainage works demonstrates that the drainage criteria used were reasonable and the implementation exceptional, and that the Inca were good engineers even though they labored without the benefit of a written language or the use of a wheel. Proof of the Inca success with drainage rests with the fact that Machu Picchu lay in the rainforest for 400 years without failure. There is no better example of successful ancient civil engineering than Machu Picchu. It was built by Native Americans before the arrival of the Spanish Conquistadors, was essentially abandoned in 1540 A.D., and endured for 4 1/2 centuries under a thick rainforest until the 20th century. Scientists, engineers, and laymen alike continue to marvel at the wonders of Machu Picchu.

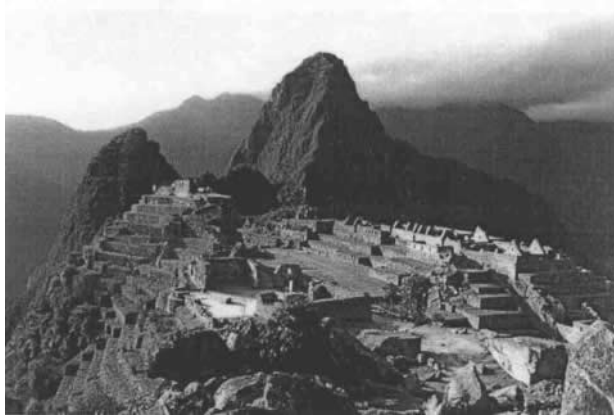
Figure 1. Machu Picchu Was in Good Condition after Four Centuries of Rain Forest Growth When Discovered by Yale Explorer Hiram Bingham in 1911. Its Longevity and Resistance to Landslides and Settlement Are Result of Extensive Drainage Systems Built by Inca in 15th and 16th Centuries.

When Professor Hiram Bingham returned to Yale University after his discovery of Machu Picchu, Peru, in 1911, he stated that "the Inca were good engineers" (Bingham 1913). Recent engineering research at Machu Picchu has demonstrated that Bingham was correct. This paper describes the carefully planned and constructed drainage infrastructure at Machu Picchu, without which it would not have endured to the present (Fig. 1).

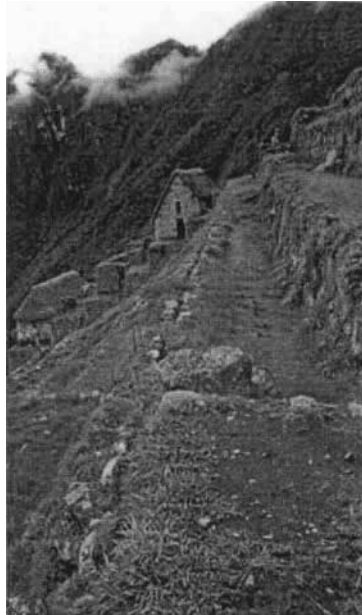
Figure 7. Canal with Qolqas (Storehouses) and Terraces in Agricultural Sector. Water Supply Canal and Agricultural Terraces Were Found in Good Condition by Bingham in 1911, Attesting to Excellent Engineering of Ancient Incas.

The excavations and laboratory test results show that the topsoil was typically 0.5 m thick, and that even at greater than 1 m deep, the subsoil of the deeper strata contained topsoil characteristics. Fortunately, the discovery of a gold bracelet in Test Pit No. 6 justified additional archaeological excavations by the INC scientists during 1996. The subsequent and more extensive excavations have shown a deep subdrainage system, representing the work of a well-organized and committed corporate agricultural society having knowledge of the importance of good drainage of soil for sustained agricultural production and foundation stability ( Fig. 6). Fig. 7 shows the stability of the agricultural terraces that supported the domestic water supply canal.

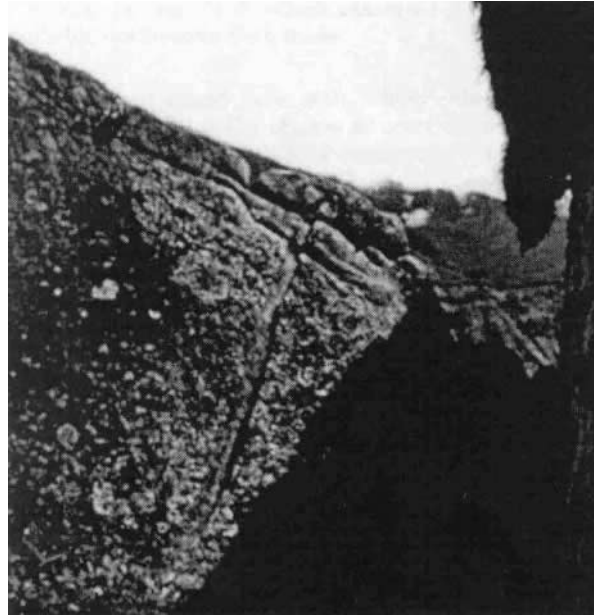
*Figure 9. Drip Line Cut into Stone behind Southern Wayrona Near the Sacred Rock. Originally, Thatched Roof Extended Out to Drip Line.*

4. Positive surface drainage of urban grassed or soil areas to drain the runoff from the many thatched roof structures and plaza areas. In some places, thatched roof drip channels were cut into rocks (Fig. 9).

Behind the southern wayrona, a large rock has a drip and drainage channel carved into it (Fig. 9). Water from the roof would drip onto the rock and be carried away from the wayrona's foundation. The location of the drip channel indicates that the Inca thatched roof was much thicker than the reconstructed thatched roof.

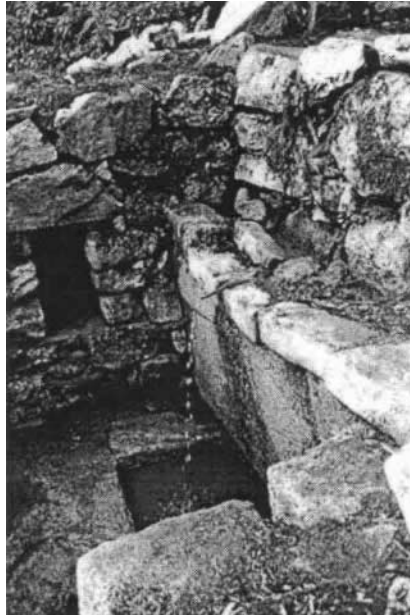
*Figure 13. Fountain 1, Immediately After Excavation. Operational Hydraulics Provided Drinking Water Source for Archaeological Crew.*

A September 1998 excavation permit from the government allowed excavation of the fountains, two of which were ceremonial fountains that were put into operation again after being buried for over four centuries (Fig. 13).

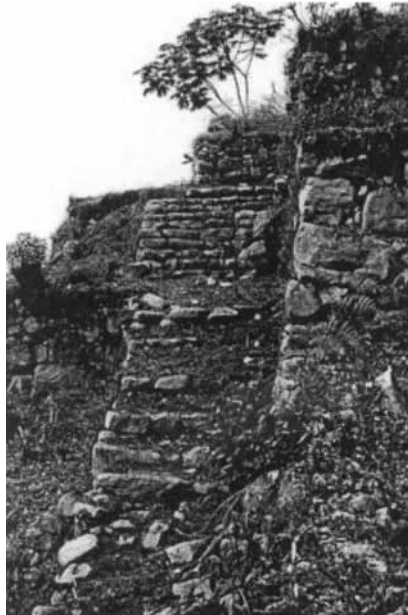
Figure 14. Main Inca Trail from Machu Picchu to Urubamba River Lying Adjacent to Fountains 3, 4, and 5 on Eastern Flank of Ridge.

The 1998 field exploration resulted in more than the excavation of the fountains: a previously unknown Inca trail was discovered. The trail is typically 2 m wide, with many excellent granite staircases ranging up to 3 m wide (Fig. 14). The Inca trail route was followed through the thick rainforest all the way down to the Urubamba River, where the ancient low water crossing was found. The trail is judged by the writers as being the primary trail from Machu Picchu to the easterly Vilcabamba region.
